Pressure Balance Valve Troubleshooting Guide

Shower valve produces loud humming / vibrating noise when water is running

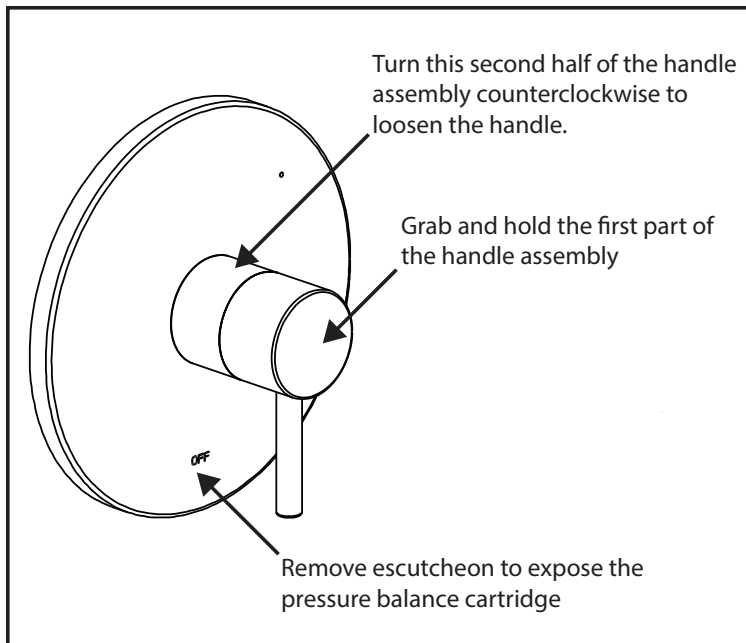
4. Clean and make sure the Cartridge is free of debris and sediments
- Remove both Stop valves with an adjustable wrench. (CAUTION: Be careful removing the Plungers and the tiny Springs when removing the Stop Valves. See Fig. 1)

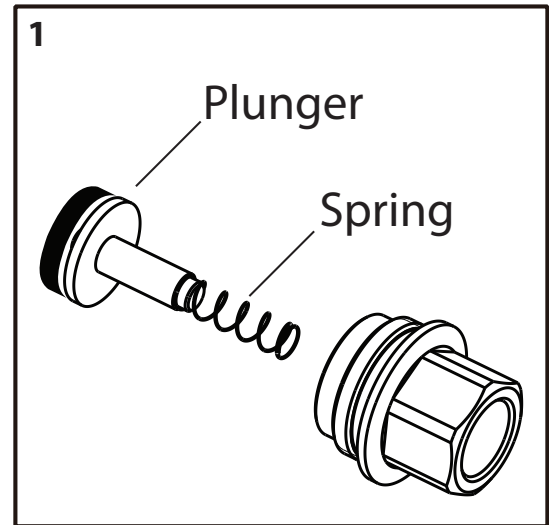
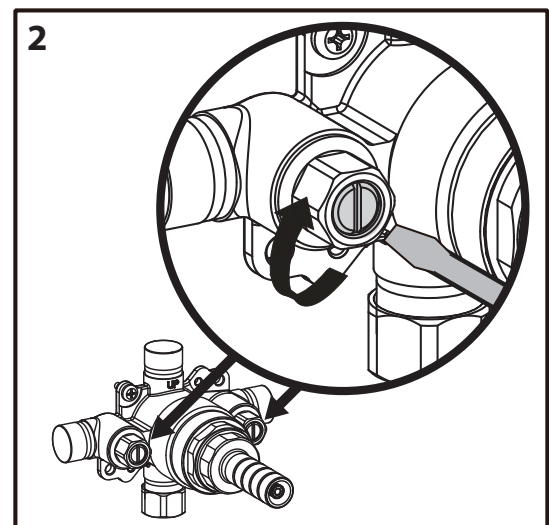
6. Clean out any remaining debris or sediments inside the valve body
 7. Re-install the Stop Valves Assemblies (including the Plungers and Springs) and use a large flat head screwdriver, turn both screws on the stop valves clockwise to close the stop valves completely. Once the valves are closed, turn the screws counterclockwise to open both valves again. Make sure to fully open the valves for maximum water flow. This step will reset the Stop Valves. (See Fig. 2)
