Model Number:  
CL105-TB  
CL105-TC

# Installation Guide

Twist Bath Tub Faucet

Two Handle Roman Tub Faucet with

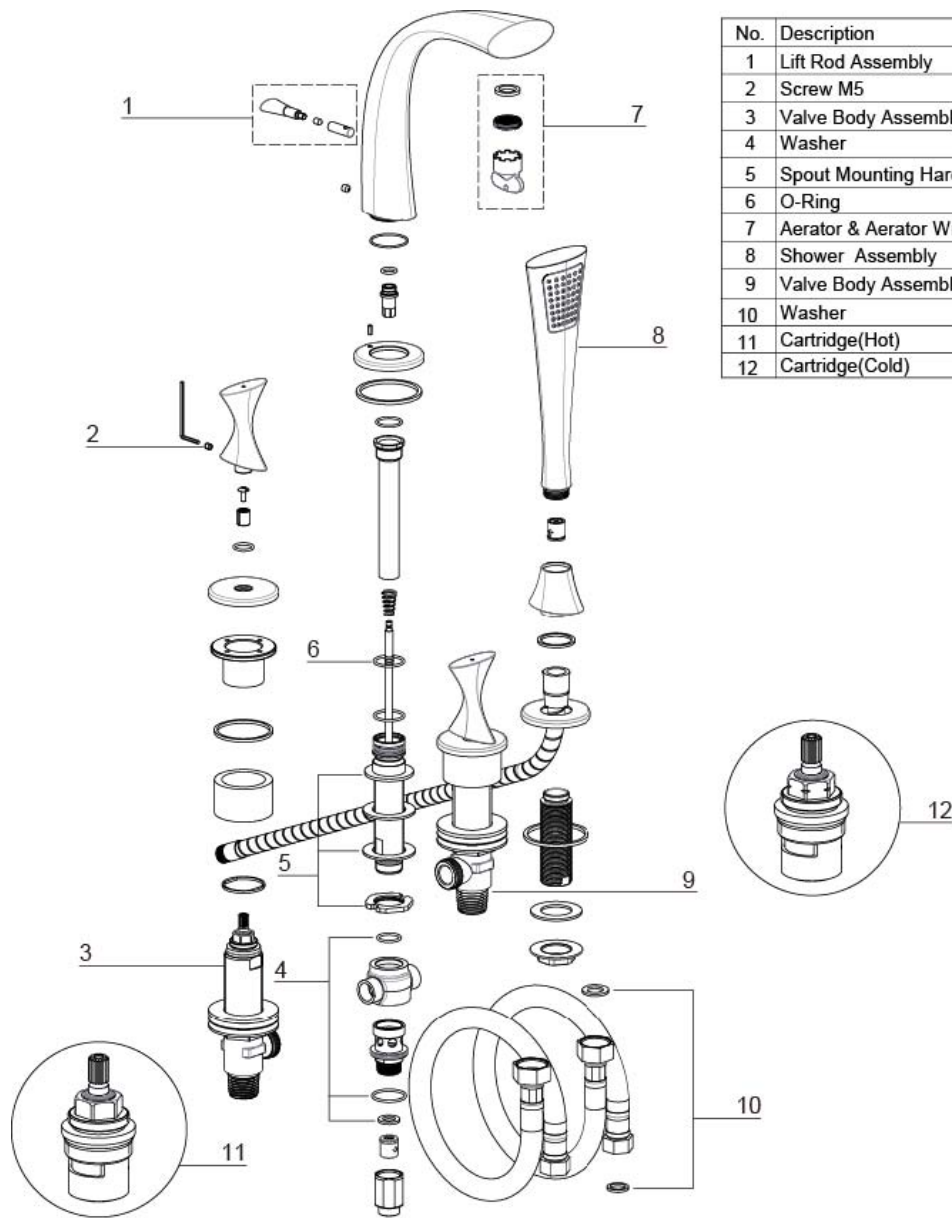
## Replacement Parts

No.	Description	Part No.
1	Lift Rod Assembly	9Q164CP
2	Screw M5	51019206NT
3	Valve Body Assembly(Hot)	5D0M0030CC
4	Washer	9Q1162PL
5	Spout Mounting Hardware	9Q1163NT
6	O-Ring	611011212
7	Aerator & Aerator Wrench	9Q1110PL
8	Shower Assembly	5F0M0086CP
9	Valve Body Assembly(Cold)	5D0M0029CC
10	Washer	9Q1161PL
11	Cartridge(Hot)	51014109NT
12	Cartridge(Cold)	51014116NT
