Model Number: CL407-TB CL407-TC CL407-TO

## Installation Guide

**Traditional Shower Faucet**

Single Handle Tub and Shower Trim

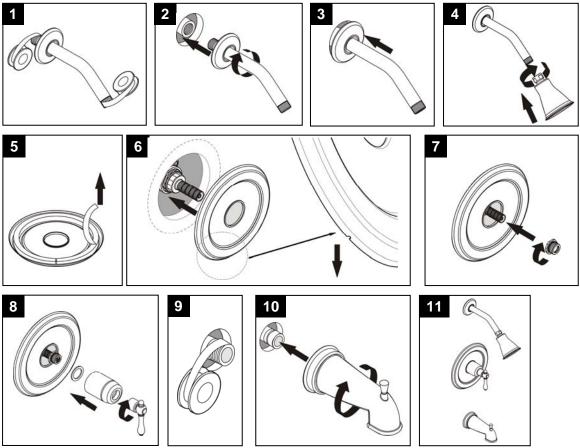
**Trouble-Shooting**

Problem -Leaks underneath Shower Head.	Cause -Retainer Shower Head has come loose. O-ring is dirty or damaged.	Action -Tighten the retainer nut. Clean or replace O-ring.
-Flow is not consistent from the shower head	-Shower head may be clogged with debris	-Unscrew the shower head from the shower arm, remove debris then reattach the shower head
